Bill Acceptor

LX7 *Series*

Installation Guide

International Currency Technologies Corp.

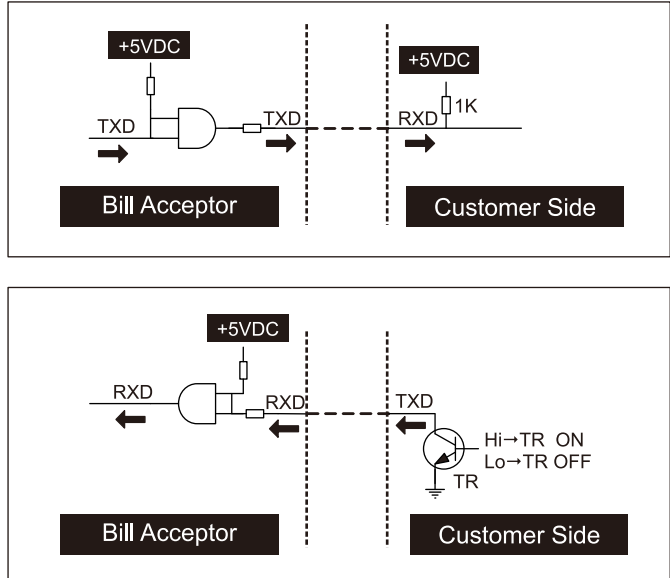
5-1-1 FIG.03

ICT-Protocol & RS232 A0 Interface.
